Location: <b>Rail Baltica Parnu - Estonian/ Latvia border. Quarrier Q80</b>	Type of sample	<b>D</b>
Soil description:  <i>Medium grained SAND</i>	Lab. No.	621S116
	Sample No	Q80 - 20
	Depth, m	-

### Proctor compaction testing result

<b>Consolidated drained direct shear test</b>		
Test method	<b>LVS EN ISO 17892-10:2018</b>	
Location: <b>Rail Baltica Parnu - Estonian/ Latvia border. Quarrier Q80</b>	Type of sample	<b>D</b>
Soil description:  <i>Medium grained SAND</i>	Lab. No.	621S116
	Sample No	Q80 - 20
	Depth, m	-

**DIRECT SHEAR RESISTANCE CURVES**

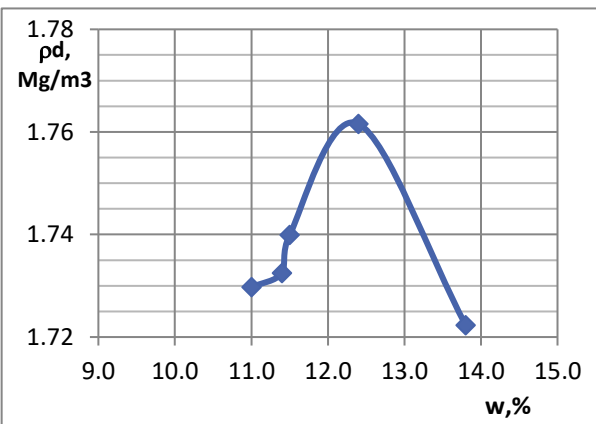
Nr.	Water content w, %	Bulk density of soil $\rho$ , Mg/m <sup>3</sup>	Dry density of soil $\rho_d$ , Mg/m <sup>3</sup>
1	11.0	1.92	1.730
2	11.4	1.93	1.732
3	11.5	1.94	1.740
4	<b>12.4</b>	<b>1.98</b>	<b>1.762</b>
5	13.8	1.96	1.722
Max dry density of soil, Mg/m <sup>3</sup>			<b>1.76</b>
Optimum moisture, %			<b>12.4</b>

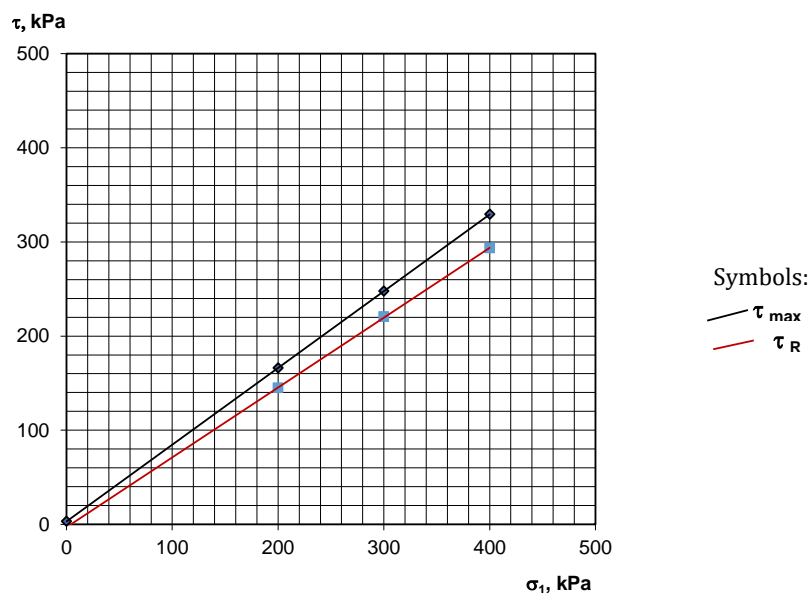
Specimen No.	Pressure σ <sub>1</sub> , kPa	Max shear strength					Residual shear strength					After testing w <sub>r</sub> , %
		H deform %	τ max, kPa	tg φ	φ', grādi	c', kPa	H deform %	τ <sub>R</sub> , kPa	tg φ	φ' <sub>R</sub> , grādi	c' <sub>R</sub> , kPa	
1	200	2.4	166.2	<b>0.815</b>	<b>39.2</b>	<b>3</b>	14.8	144.8	<b>0.743</b>	<b>36.6</b>	<b>0</b>	21.0
2	300	2.3	247.6				14.8	220.4				18.0
3	400	2.8	329.2				14.7	293.3				17.7

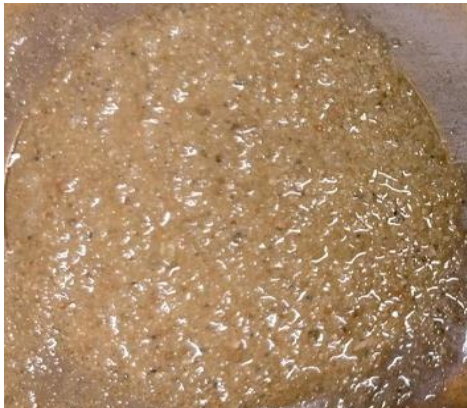
Specimen 1

**Photos of the specimen in shear plane**

$\sigma_1 = 200\text{kPa}$

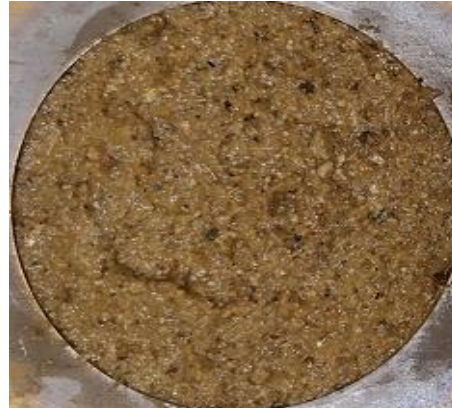
Specimen 2

$\sigma_1 = 300\text{kPa}$

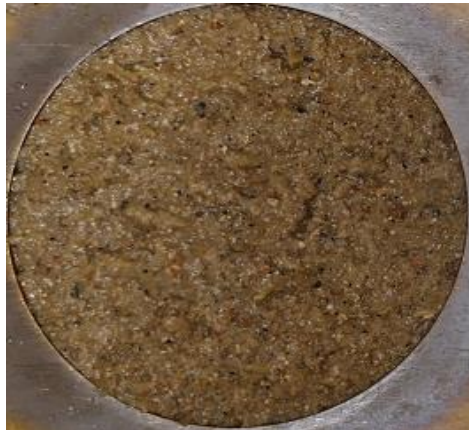
Specimen 3

$\sigma_1 = 400\text{kPa}$
